C2 – TK-561 BRIM™

Mild hydrocracking unit (at a European refinery)

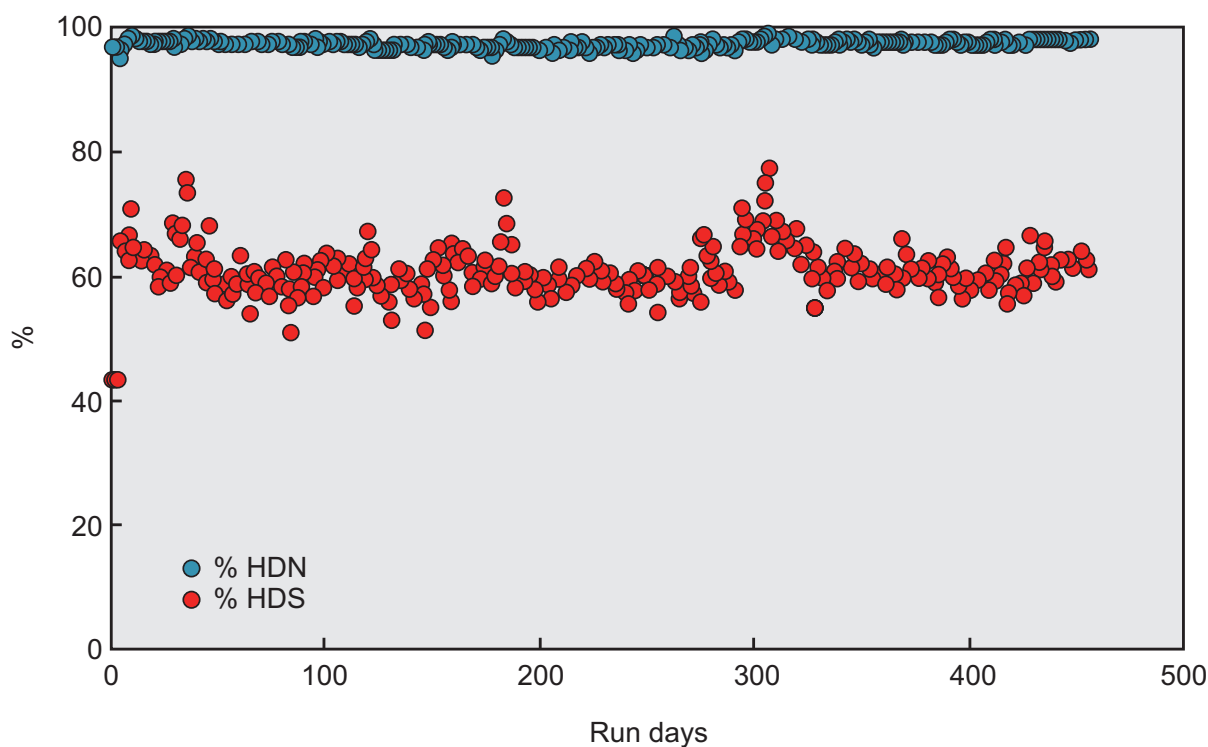
Figure 1 % HDS/HDN with TK-561 BRIM™

the catalyst. The operation is adjusted to meet a sulphur specification in the FCC naphtha of 18 wt ppm; this requires 300-500 wt ppm sulphur in the unconverted VGO (FCC feed). Along with the HDS, more than 60% nitrogen removal is also obtained (Figure 1). It is also desirable to convert as much VGO into diesel as possible (Figure 2). As a consequence of the challenging product qualities, the reactor temperature has been very high since start-of-run.

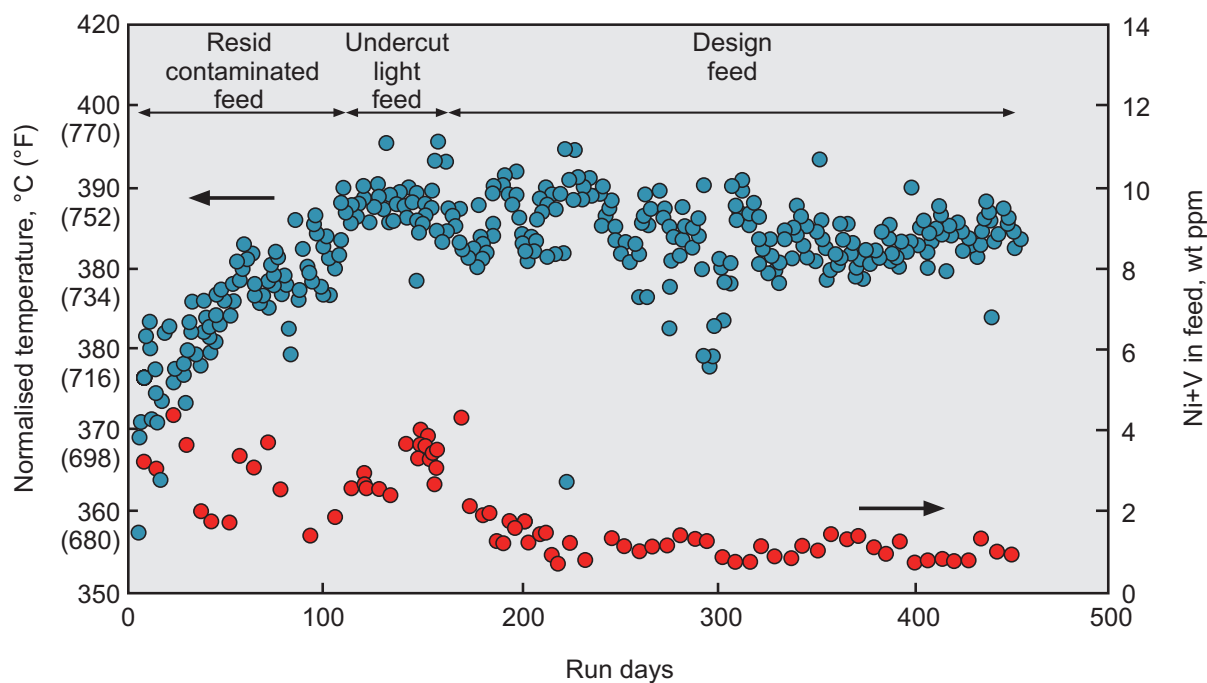
Figure 3 HDS deactivation with TK-561 BRIM™

During the initial four months of the cycle, the quality of the processed feedstock was quite low. This was caused by fouling problems in the vacuum distillation, giving entrainment of resid in the vacuum gas oil fraction. This feed change is seen as a small but heavy tail end with significant amounts of asphaltenes and metals. The consequence was evident: very rapid deactivation caused by catalyst poisoning. The root to the problem was difficult to spot since most analyses appeared in spec. However, the analysis for Ni+V proved that the feedstock quality suffered heavily. After identifying the problem, the feed was initially undercut to make it lighter and to reduce nitrogen. After the vacuum distillation was given maintenance, the full-range feedstock quality improved dramatically. Since that change, the deactivation profile has been flat, and the operation very stable (Figure 3).
